Operational Discipline and Initiatives taken in Battery.

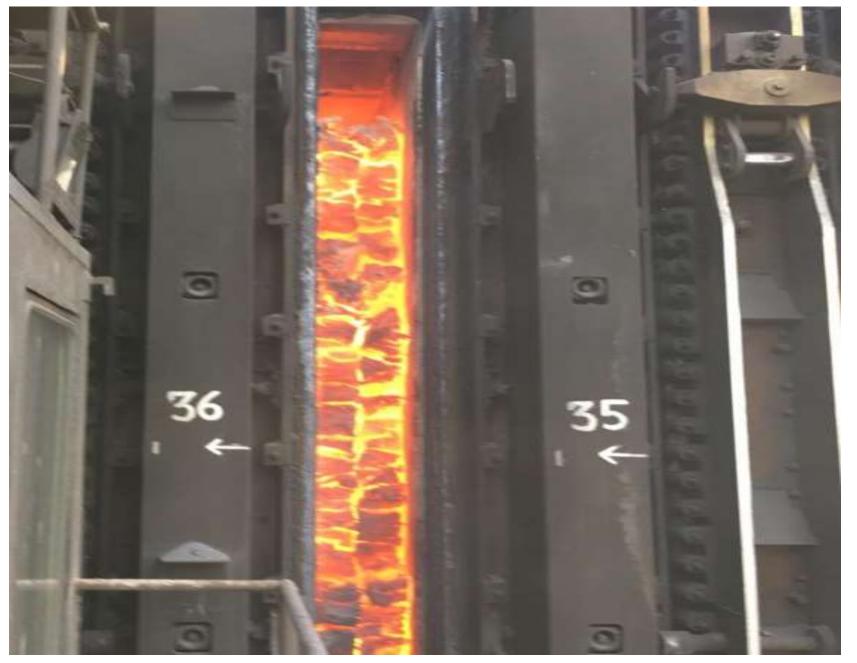
Moving car after opening door and keeping door open for long time.

WHAT WAS THE RESULT?: Unwanted Heavy coke fall due to coke coming in contact with air and machine movement vibrations.

Machine is moved after opening door

WHAT TO DO ?: Under normal conditions, pusher car/guide car should not be moved after opening door, and door should be opened only after clearance.

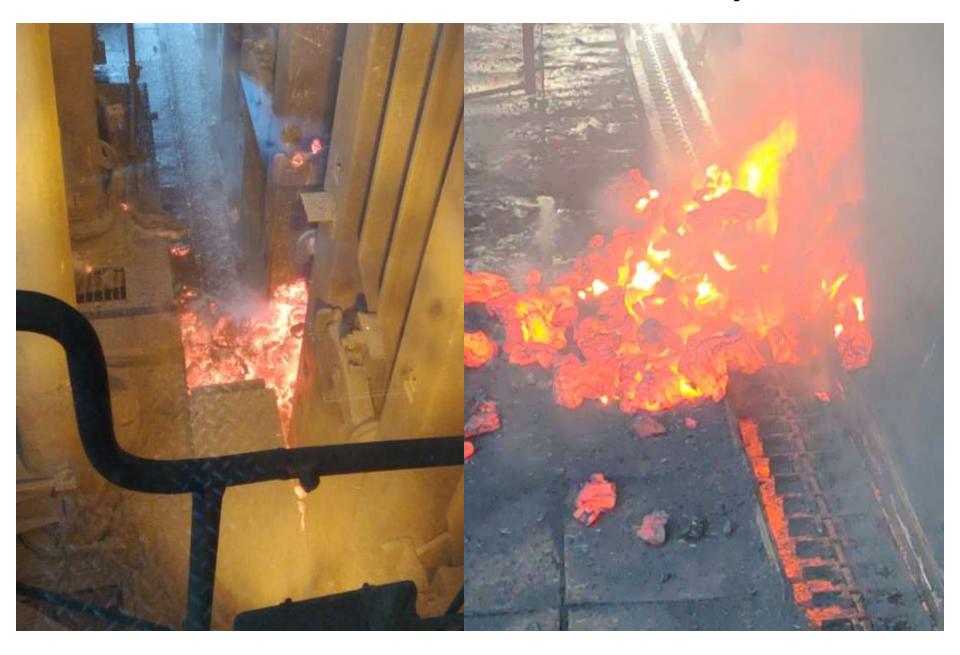
- 1. Safety Issue
- 2. Damage To Chain Conveyor And Service Platform

Coke fall on chain conveyor

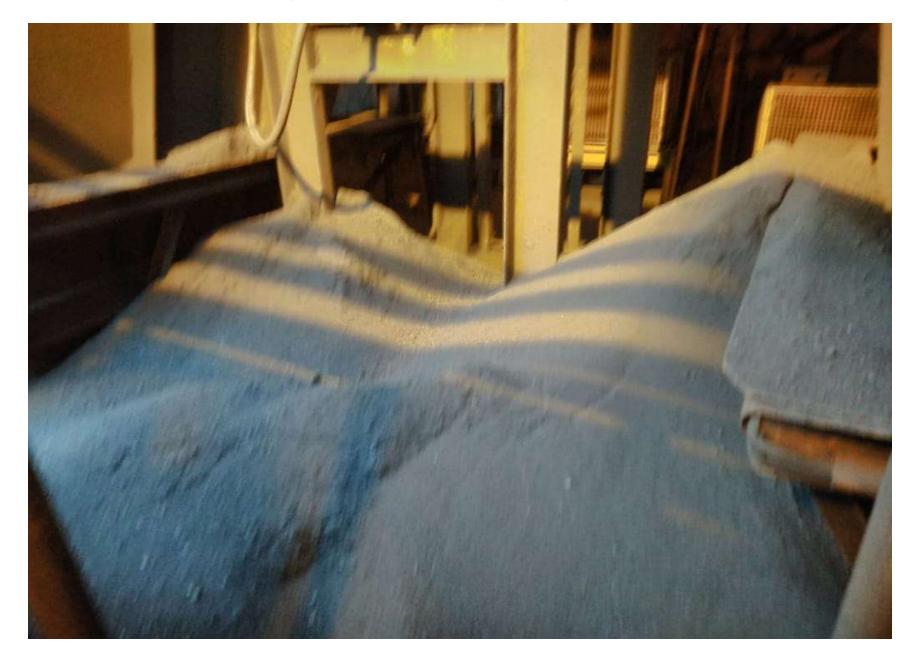
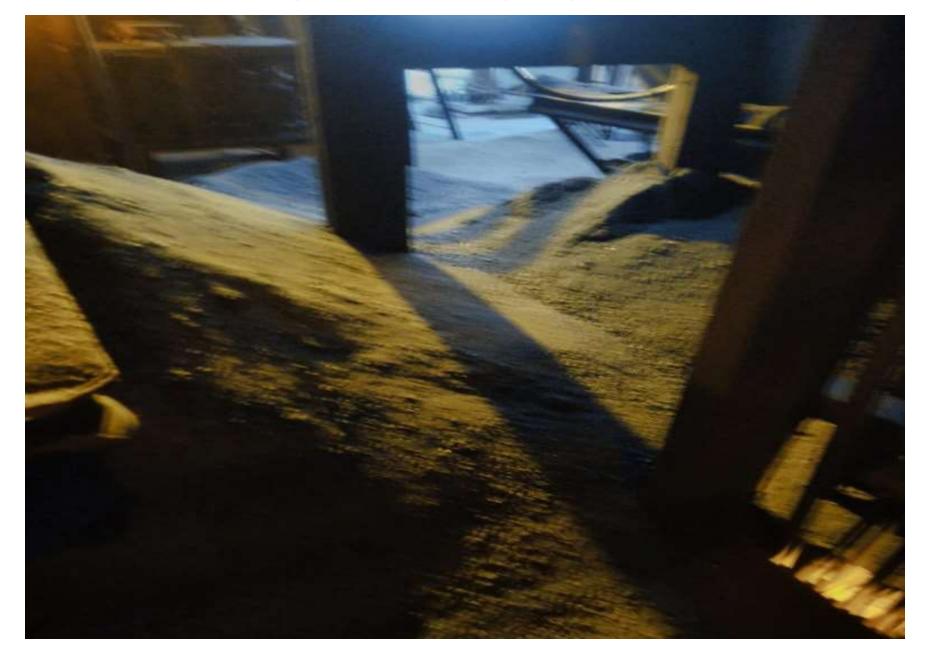
WHAT WAS THE RESULT?: Unwanted coal spillage in charging car platform and coal tower area, due to coal coming out of hopper after hopper is full.

Coal spillage in charging car platform

WHAT TO DO ?: a) Minimal air blasting to be done.

- b) Regular checking of hopper nets to be done.
- c) Vibrators may be used as per the laid down procedure.

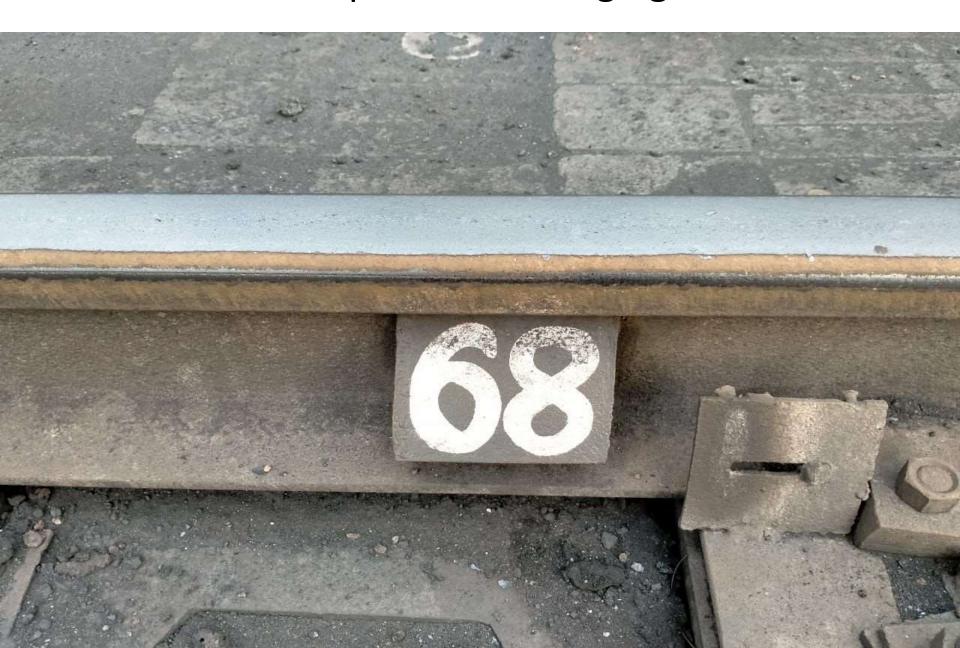
New Number plates for charging car center

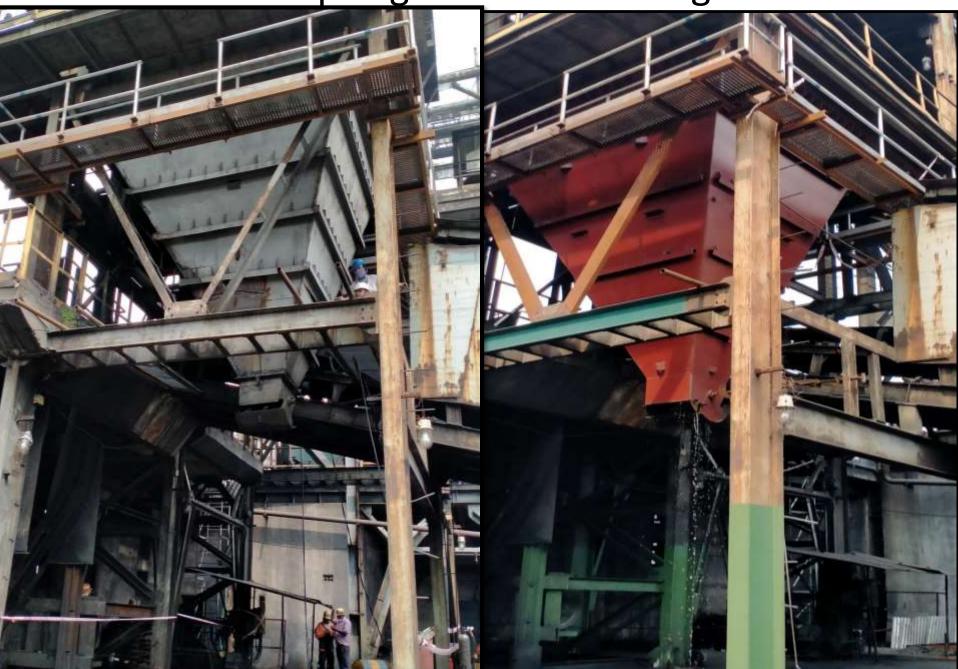
Coke spillage bunker is changed

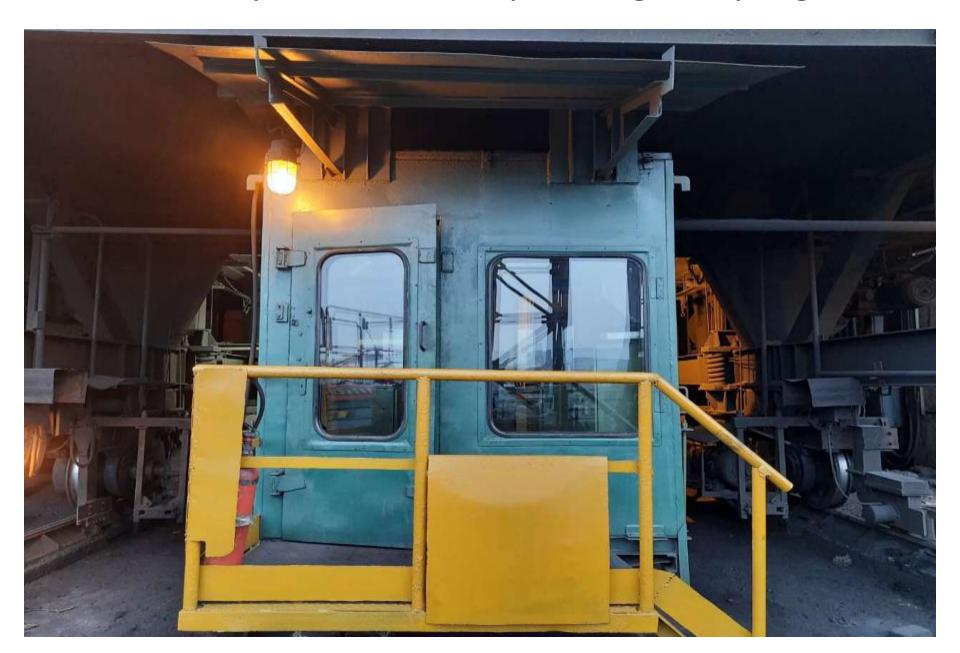
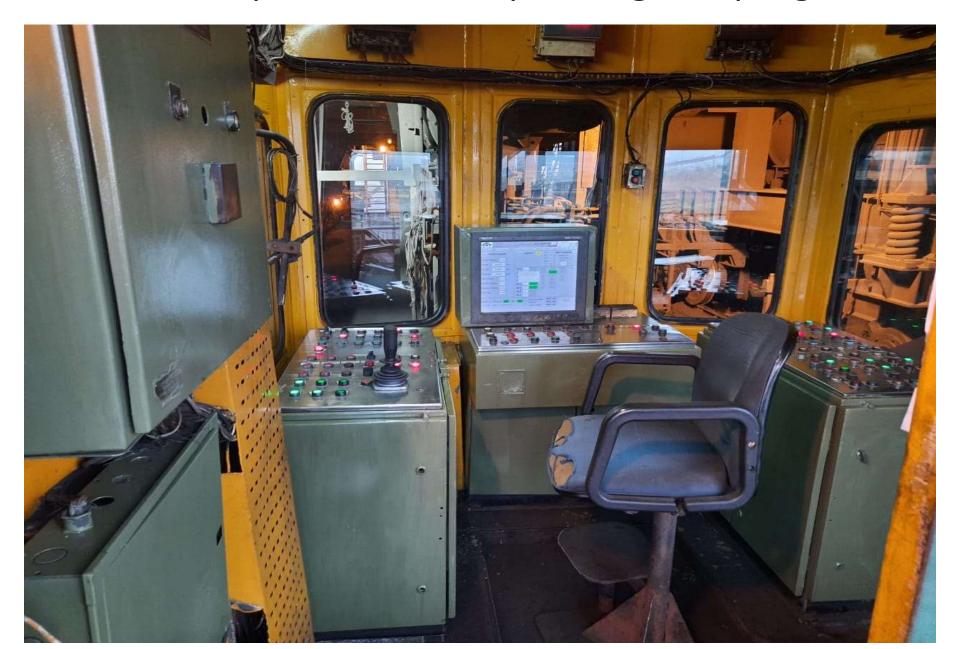
Machine operators cabin painting – in progress.
